## DS111

# DOLPHIN INFRARED WALL TAP – THRU PANEL

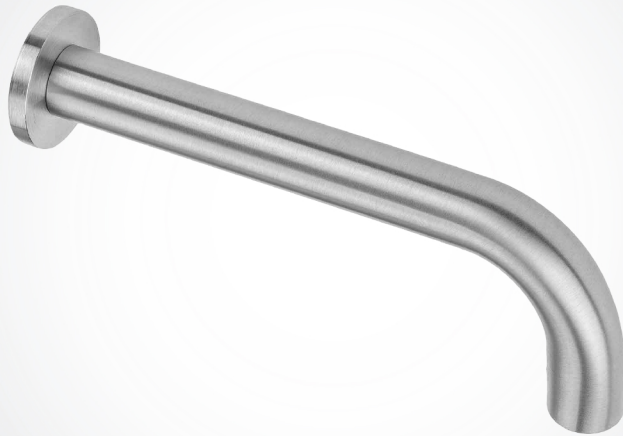
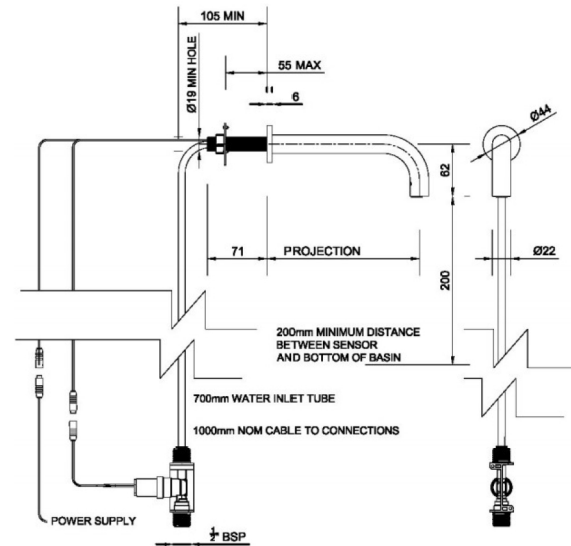
- > Infrared Touch Free Tap – for ultimate hygiene – prevents cross contamination, sensor mounted in end of spout
- > Designed to be mounted through an IPS panel\*

- > 90° spout
- > Max nominal flow rate of 3.5LPM (between 1 and 6 bar) as standard, and is also available with 4, 3, 2, 1.75, and 1LPM flow rates on special request

| <b>DIAMETER</b> | <b>22MM</b> |
| <b>PROJECTION</b> | <b>150/175/200/225MM</b> |
